SUMMARY REPORT  
FOR  
ALUMINUM BONDED LEAD TELLURIDE THERMOELECTRIC  
MODULE STUDY FOR NON-MAGNETIC AND  
VACUUM APPLICATIONS  
(5 March 1968 – 5 November 1968)

Contract No. NAS 5-11514

Prepared by  
Atomics International  
A Division of North American Rockwell Corporation  
Post Office Box 309  
Canoga Park, California 91304  
for  
Goddard Space Flight Center  
Greenbelt, Maryland

February 7, 1969

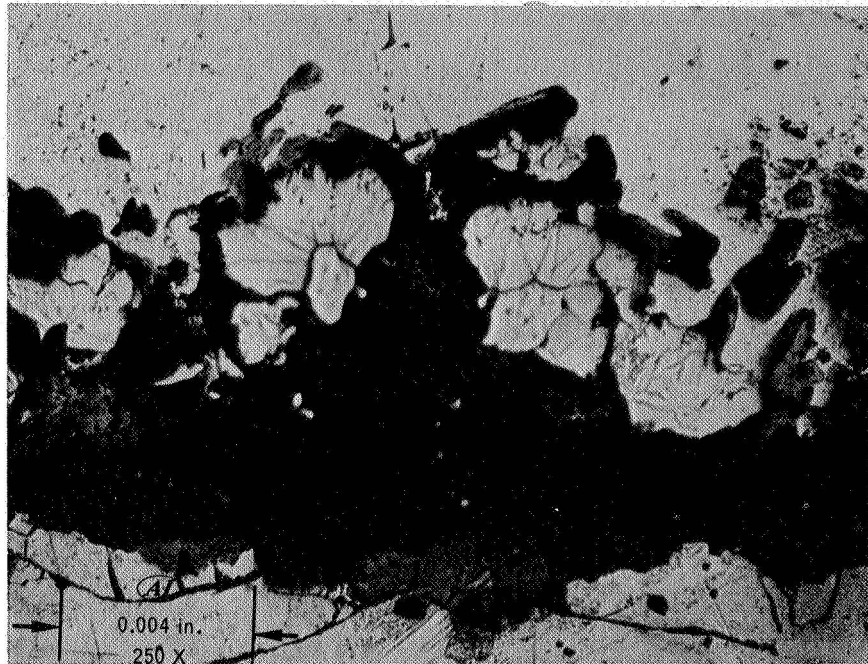
**Figure 22. Failed Hot Shoe Bond Operated 11,600 Hours at 800°F (2P)**

The structure at a hot-side contact which failed when the couple was being removed from the module is shown in Figure 22. This interface operated at about 800°F for more than 11,000 hours (SMT-3). Although this (separated) bond region was in poor condition for metallographic examination, it is observed that the tungsten particles in the center of the photomicrograph have material clinging to them which is made up mostly of another solid phase. This phase could not be analyzed, but, based on past experience, it is suspected to be aluminum telluride. Aluminum telluride has a high electrical resistivity and is very unstable in air, transforming to aluminum oxide or hydroxide and volatile hydrogen telluride, in the presence of water vapor. Therefore, direct verification of its presence is difficult. The hot-side contact region of thermocouples from the same module (SMT-3), operating at 750°F and lower temperatures, did not show the presence of this new phase.

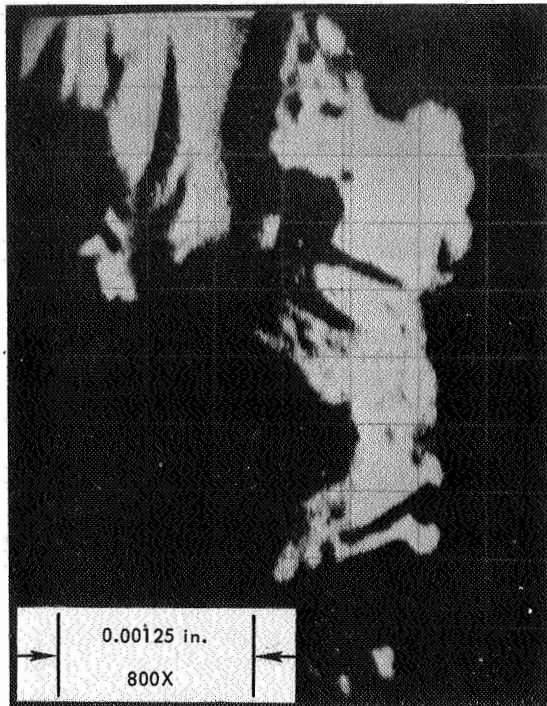
In an attempt to verify the interaction of aluminum and tellurium, the bond regions of thermoelements were examined using an electron beam microprobe. In this analysis method, the bond region under study is scanned with an electron beam. Detectors are used to pick up back-scattered electrons and X-rays characteristic of the chemical elements present in the surface of the area being scanned. The detector signal is used to modulate the intensity of an oscilloscope beam which is scanning the oscilloscope screen in synchronization with the probe beam over the sample scan area. Photographs of the oscilloscope trace are used for evaluation. White areas on X-ray scans represent regions where a given chemical element is present, while white areas on back-scattered electron scans represent areas where heavy elements such as Pb and W are present.

A comparison of Figures 23b and 23c (800°F, 3N) suggests that interpenetration of Al and Te has occurred, while a similar comparison for Figures 24b and 24c, another section of the same bond, throws doubt on this conclusion. Comparison of the Te and Al scans of Figure 25 (750°F, 3N) suggests that little, if any, interdiffusion of Al and Te occurred. In view of what has been noted about the instability of aluminum telluride, it is not surprising that these scans do not always show the expected interpenetration and compound formation between Al and Te. The microprobe electron beam penetrates into the surface to only about one micron, a depth to which aluminum telluride could easily react with atmospheric water vapor.

The conclusion to be drawn from this analysis is that aluminum-contacted PbTe operates with reasonable stability at 750°F, while operation at 800°F results in serious bond deterioration. The mode of deterioration at the higher operating temperatures is believed to be the formation of aluminum telluride, which causes the observed resistance increase in the thermocouple. It would also account for a reduction in the strength of the contact due to the brittleness of the aluminum-tellurium compound, and perhaps a tendency of the compound growth process to disrupt existing mechanical bonds.
